B. C. I

Stucco Inspections

Report Prepared For:
John Doe
12345 My Street Dr.
Charlotte NC 28202

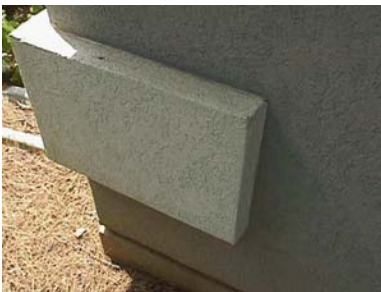
Flat accents/quoins need to be caulked

All flat accents and quoins need to be caulked. Chapter 2 and Chapter 4, Sections 2 & 8

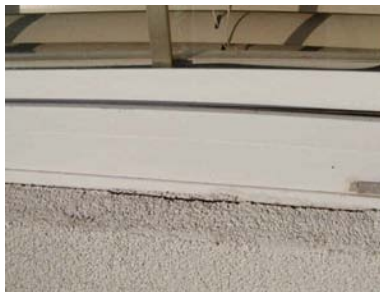
Typical exposed cracks at window

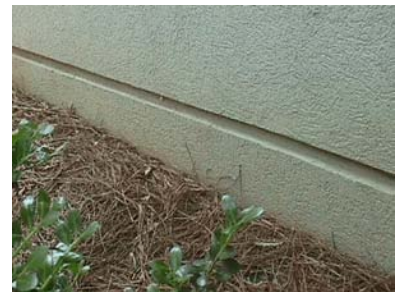
Termite band is installed

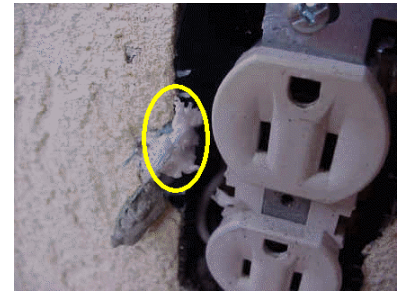
J-6: ID at outlet: blue mesh, EPS, gray base coat

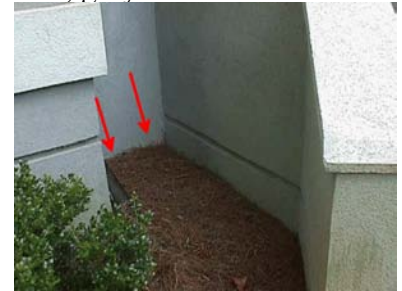
Small area foam in ground contact

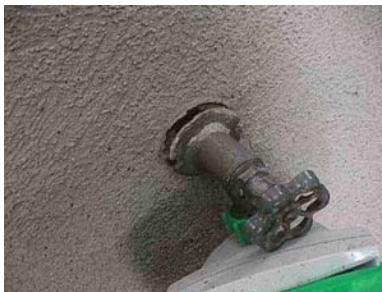
Hose bibb needs to be caulked

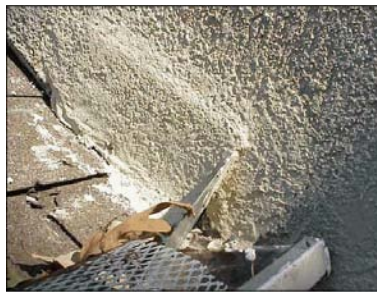
D-2: Kickout caulked to shingle

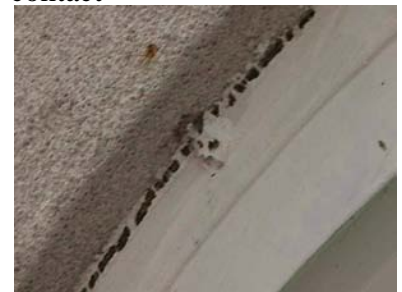
D-3: Need to caulk at half round window

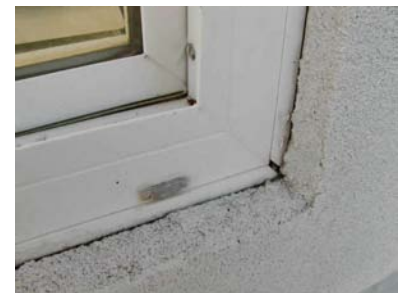
F-6: Large cracks at window

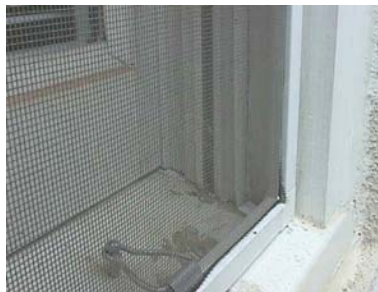
Miter joints not caulked

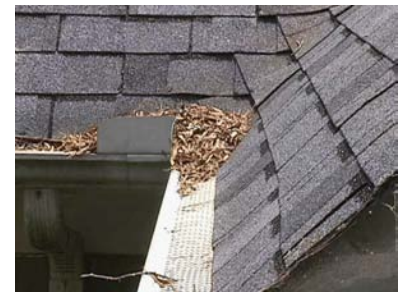
B-3: Clear leaves from gutter/roof

Gutters and downspouts need to be cleared of any visible leaves and debris.

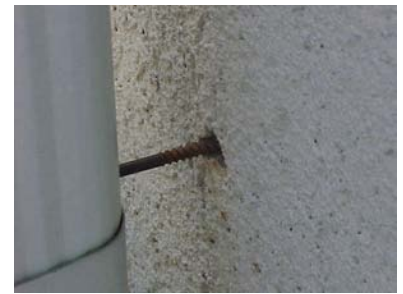
Downspout connection hole

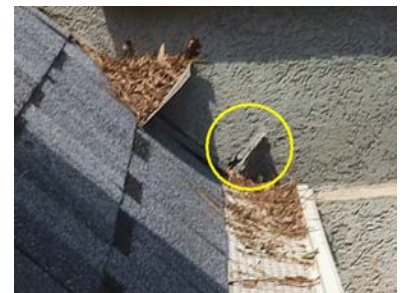
Kickout improperly installed. Clear leaves from area.

Several of the kickouts appear to be installed improperly and/or failing. The kickout flashing should penetrate the stucco cladding to function properly. The remaining kickouts appear to be functioning properly. Chapter 2 and Chapter 4, Section 3

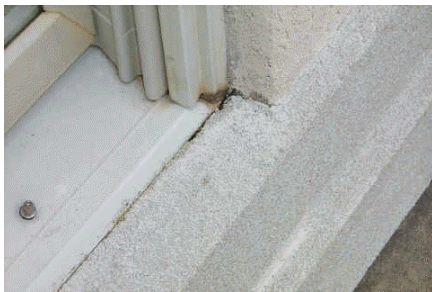
E-7: Window needs to be caulked

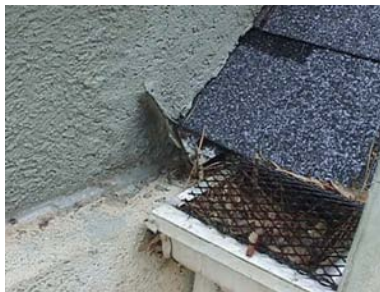
Kickout installed

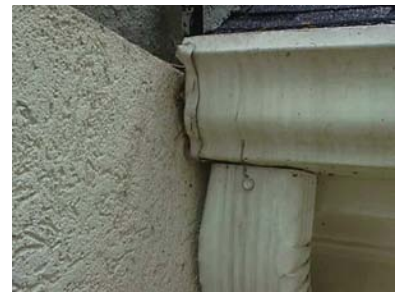
Gutter below kickout

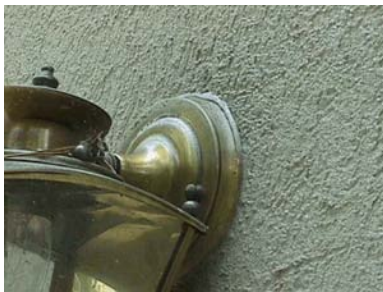
Light fixture needs caulk

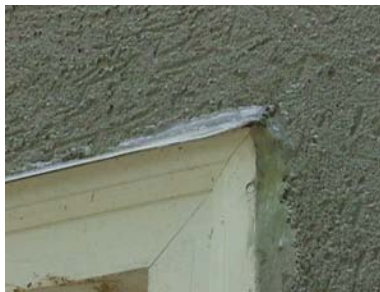
Flashing at garage

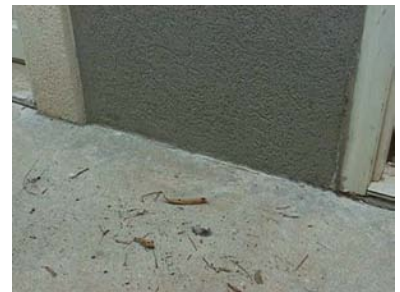
System in contact with concrete. No termite band.

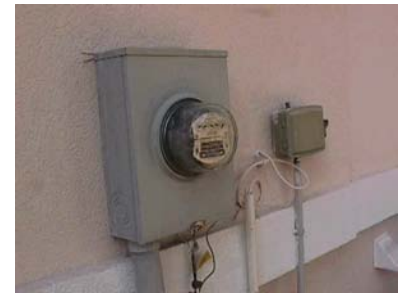
Utility breaches need caulk

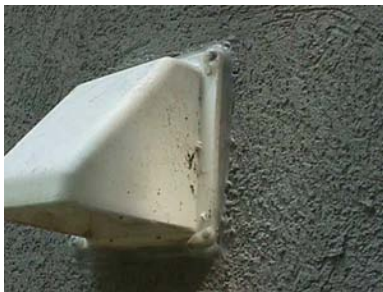
Vent needs to be caulked

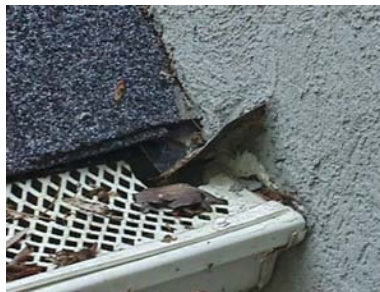
Kickout installed

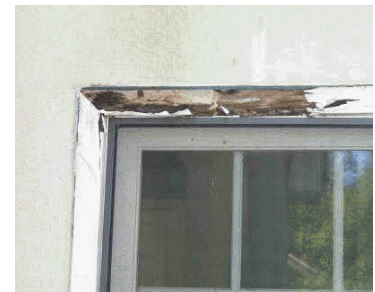
Wood rot to brick mold below kickout

External wood rot noted at windows, doors or wood trim areas needs to be repaired.
Chapter 2

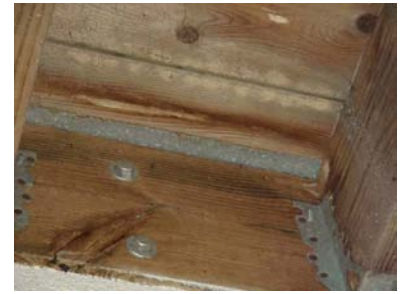
Deck flashing installed

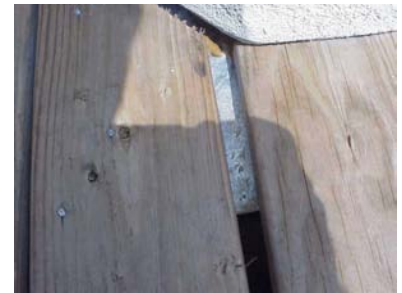
Deck flashing installed

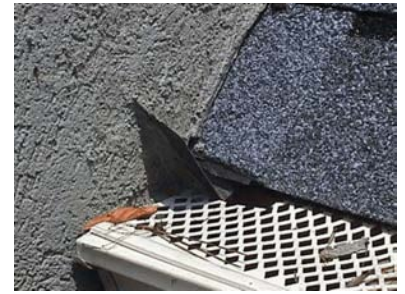
Kickout on right side of chimney

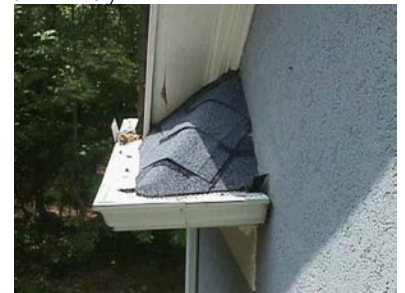
Kickout installed at roof saddle:secondary location

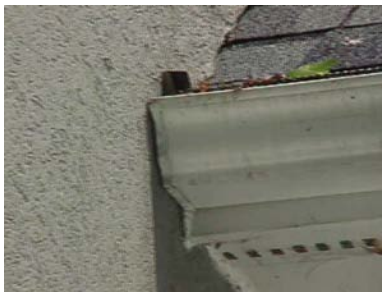
A-5: Kickout installed. Need to clean gutter.

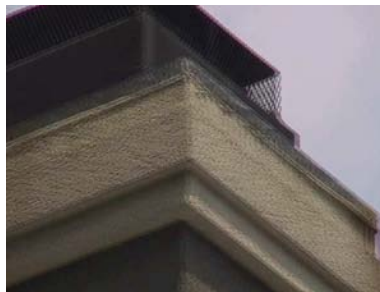
Chimney cap covers entire top of chimney

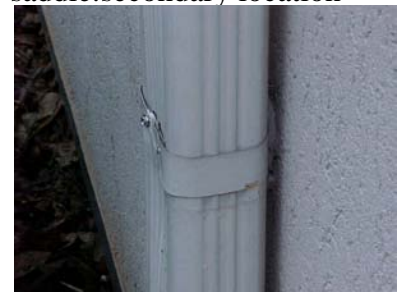
Caulk downspout attachments

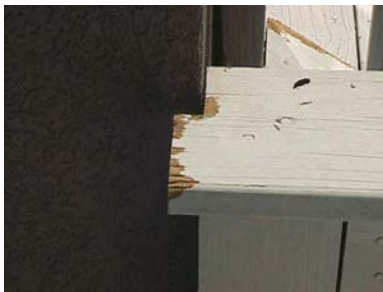
Paint peeling at porch

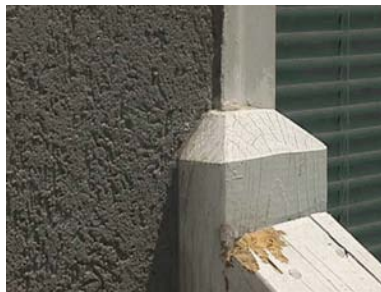
Paint peeling. Seal joint at house.

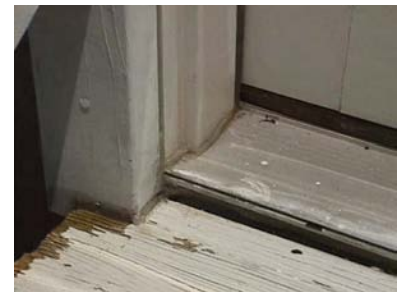
Need to door miter joint and threshold

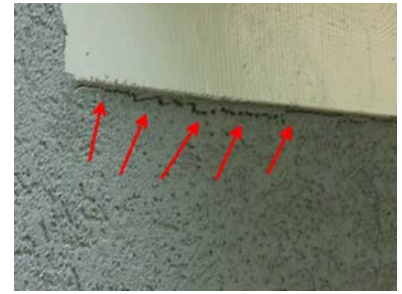
Exposed crack needs to be caulked

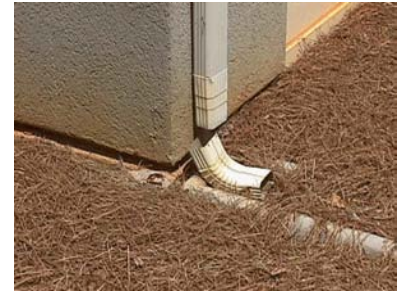
A-8: Repair downspout

Gutter downspout needs to be reattached to redirect water drainage away from the house. See report for location.
